Report | Apr 13, 2021

LEAKEXPERT

Sample report

Sonotec GmbH
Nauendorfer Straße 2
06112 Halle

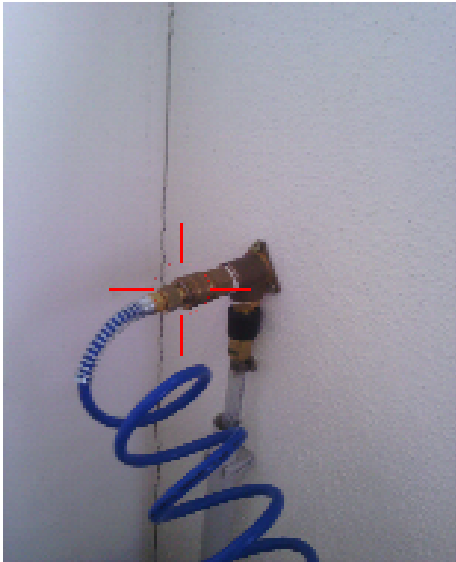
Rating	ID	LOSS [l/min]	L _{eq} [dB]	p [bar g]	Gas	Priority	Tester	Date
4	10176-489	12.17	69	8.0	Air	Medium	Sonotec	Apr 13, 2021
							Notes

Position (Building/Area/System/Component)					Repair state	Repair technician	Repair date	
Hall 2/Gravure room/Preparation/Plug nipple					To be repaired	Kevin Lang	Apr 13, 2021

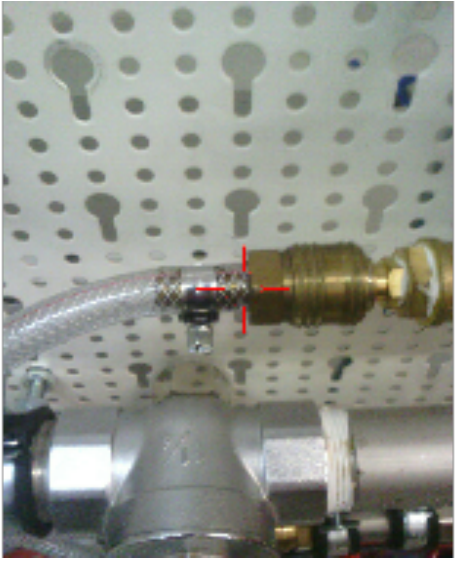
Rating	ID	LOSS [l/min]	L _{eq} [dB]	p [bar g]	Gas	Priority	Tester	Date
3	10176-488	8.13	74	4.0	Air	Medium	Sonotec	Apr 13, 2021
							Notes

Position (Building/Area/System/Component)					Repair state	Repair technician	Repair date	
Hall 2/Laboratory/Test rig/Hose clamp					To be repaired

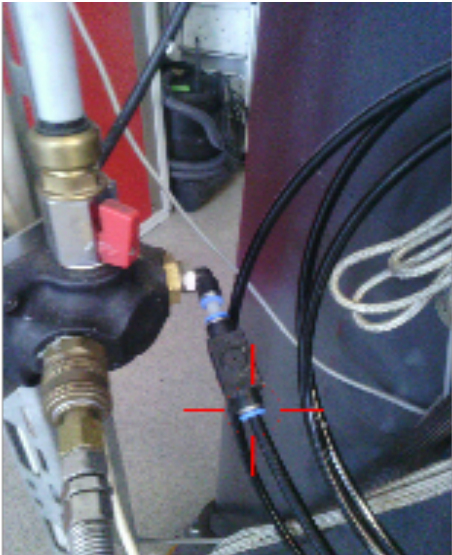
Rating	ID	LOSS [l/min]	L _{eq} [dB]	p [bar g]	Gas	Priority	Tester	Date
3	10176-494	8.09	74	4.0	Air	Low	Sonotec	Apr 13, 2021
							Notes

direct connection without shut-off valve	
Position (Building/Area/System/Component)					Repair state	Repair technician	Repair date	
Hall 1/mechanical processing/Milling machine/Connector					To be repaired

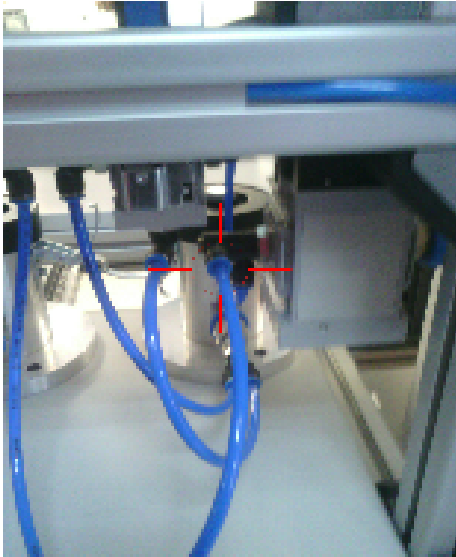
Rating	ID	LOSS [l/min]	L _{eq} [dB]	p [bar g]	Gas	Priority	Tester	Date
2	10176-487	6.92	58	4.0	Air	Low	Sonotec	Apr 13, 2021
							Notes

Position (Building/Area/System/Component)					Repair state	Repair technician	Repair date	
Hall 3/Production/Test device/Connector					To be repaired

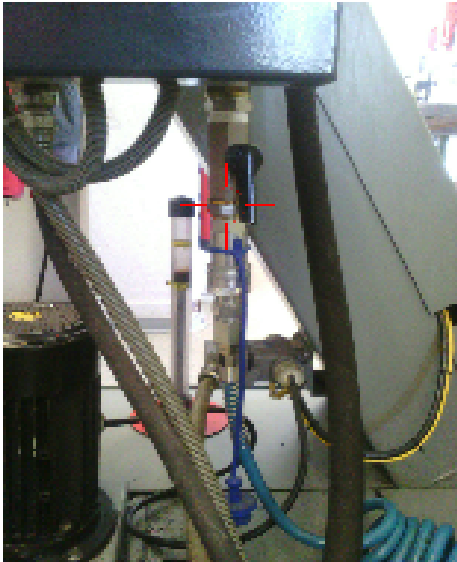
Rating	ID	LOSS [l/min]	L _{eq} [dB]	p [bar g]	Gas	Priority	Tester	Date
<input checked="" type="checkbox"/>	10176-497	65.57	97	8.0	Air	High	Sonotec	Apr 13, 2021

Notes	
Position (Building/Area/System/Component)					Repair state	Repair technician	Repair date	
Hall 1/mechanical processing/Compressed air connection/Shutoff valve					Repaired	Kevin Lang	Apr 13, 2021

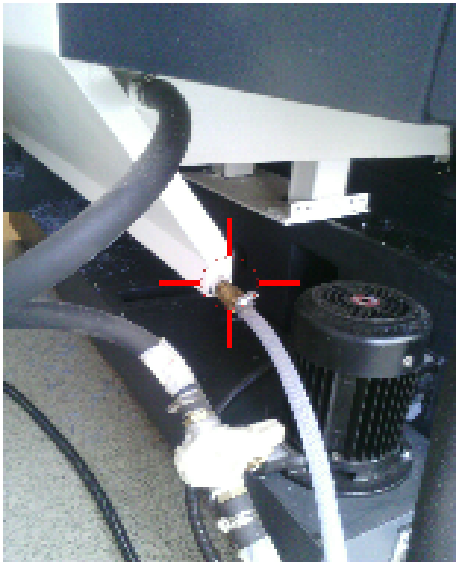
Rating	ID	LOSS [l/min]	L _{eq} [dB]	p [bar g]	Gas	Priority	Tester	Date
<input checked="" type="checkbox"/>	10176-500	51.00	95	8.0	Air	High	Sonotec	Apr 13, 2021

Notes	
Position (Building/Area/System/Component)					Repair state	Repair technician	Repair date	
Hall 1/mechanical processing/Milling machine/Connector					Repaired	Kevin Lang	Apr 13, 2021

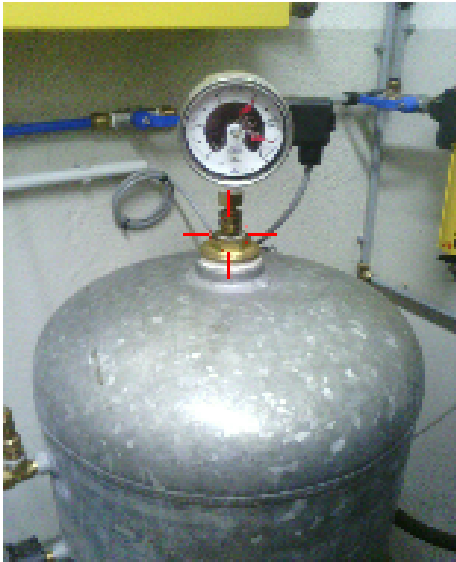
Rating	ID	LOSS [l/min]	L _{eq} [dB]	p [bar g]	Gas	Priority	Tester	Date
<input checked="" type="checkbox"/>	10176-490	36.55	91	8.0	Air	High	Sonotec	Apr 13, 2021

Notes	
Position (Building/Area/System/Component)					Repair state	Repair technician	Repair date	
Hall 1/Compressor room/Compressor air tank/Plug-in connector					Repaired	Kevin Lang	Apr 13, 2021

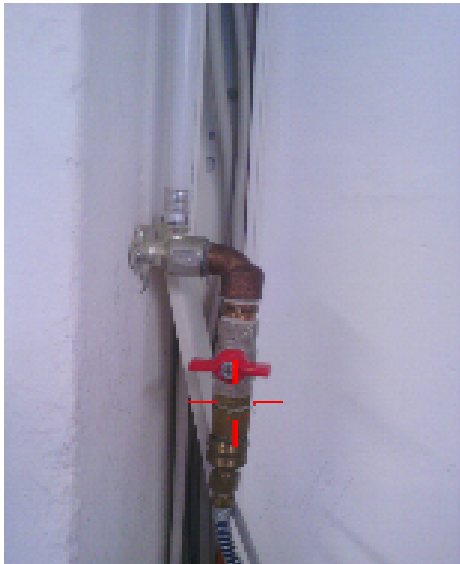
Rating	ID	LOSS [l/min]	L _{eq} [dB]	p [bar g]	Gas	Priority	Tester	Date
<input checked="" type="checkbox"/>	10176-501	29.60	89	8.0	Air	High	Sonotec	Apr 13, 2021

Notes	
Position (Building/Area/System/Component)					Repair state	Repair technician	Repair date	
Hall 3/Grinding room/Grinding machine/Connector					Repaired	Kevin Lang	Apr 13, 2021

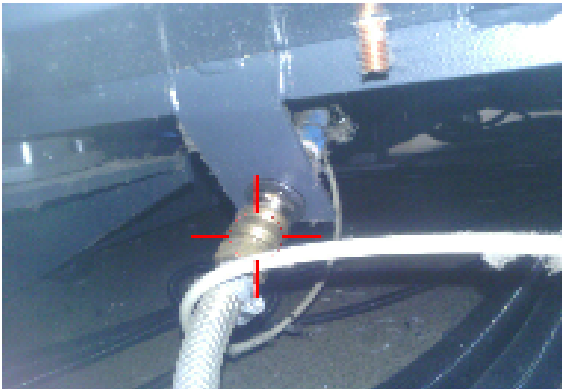
Rating	ID	LOSS [l/min]	L _{eq} [dB]	p [bar g]	Gas	Priority	Tester	Date
<input checked="" type="checkbox"/>	10176-492	13.09	77	8.0	Air	Medium	Sonotec	Apr 13, 2021
							Notes

Position (Building/Area/System/Component)					Repair state	Repair technician	Repair date	
Hall 1/mechanical processing/Five-axis milling machine/Connector					Repaired	Kevin Lang	Apr 13, 2021

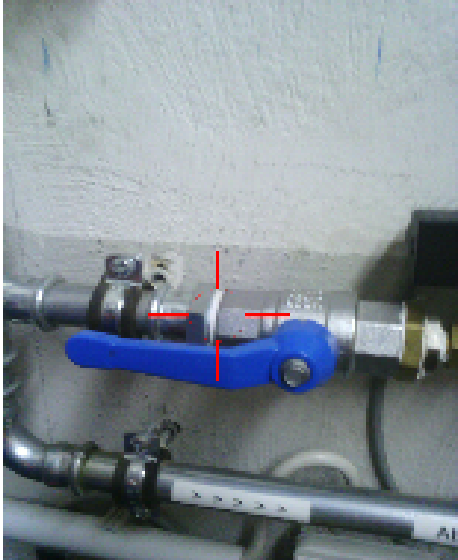
Rating	ID	LOSS [l/min]	L _{eq} [dB]	p [bar g]	Gas	Priority	Tester	Date
<input checked="" type="checkbox"/>	10176-491	12.68	74	8.0	Air	Medium	Sonotec	Apr 13, 2021

Notes use sealing cord for repairs	
Position (Building/Area/System/Component)					Repair state	Repair technician	Repair date	
Hall 1/Compressor room/Compressed air distribution/Shutoff valve					Repaired	Kevin Lang	Apr 13, 2021
